**THE STREAMBANK EROSION CONTROL
EVALUATION AND DEMONSTRATION ACT OF 1974
SECTION 32, PUBLIC LAW 93-251**

Appendix F - Yazoo River Basin Demonstration Projects

Consisting of
A COMPREHENSIVE SUMMARY REPORT ON STREAMBANK
EROSION CONTROL DEMONSTRATION PROJECTS CONSTRUCTED
IN EIGHT WATERSHEDS OF THE YAZOO RIVER BASIN

U.S. ARMY CORPS OF ENGINEERS
December 1981

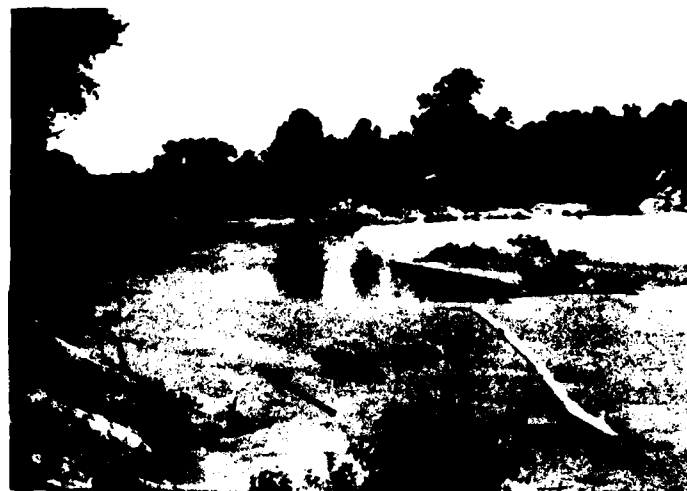
After Damage
Looking Downstream
Along Old Dike Alignment
July 1980

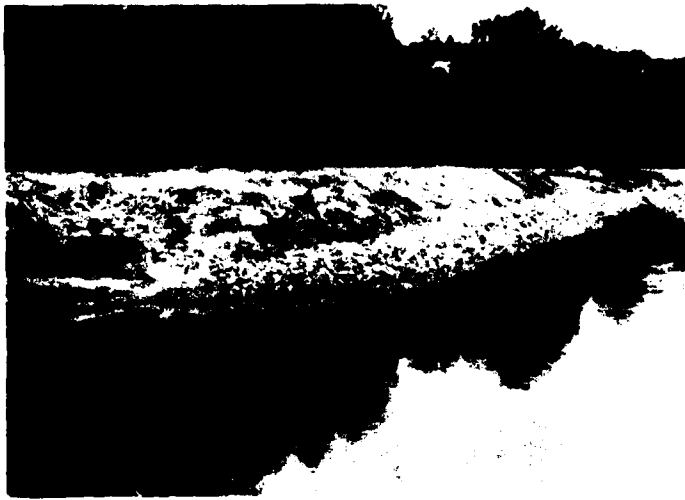
After Construction
Nov 1977

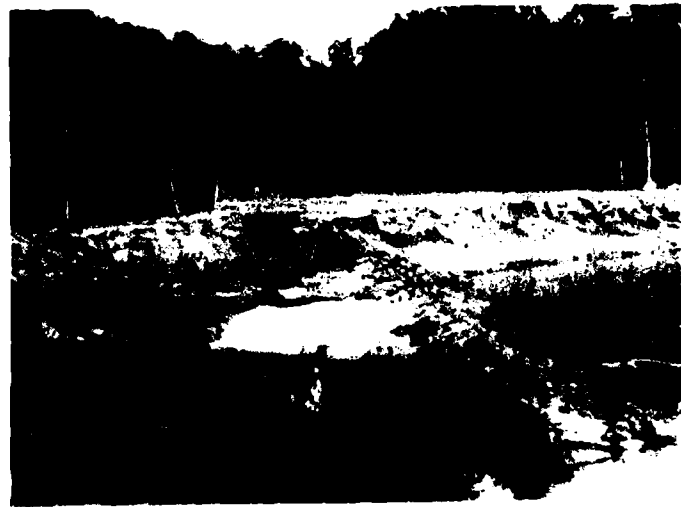
After Damage
May 1978

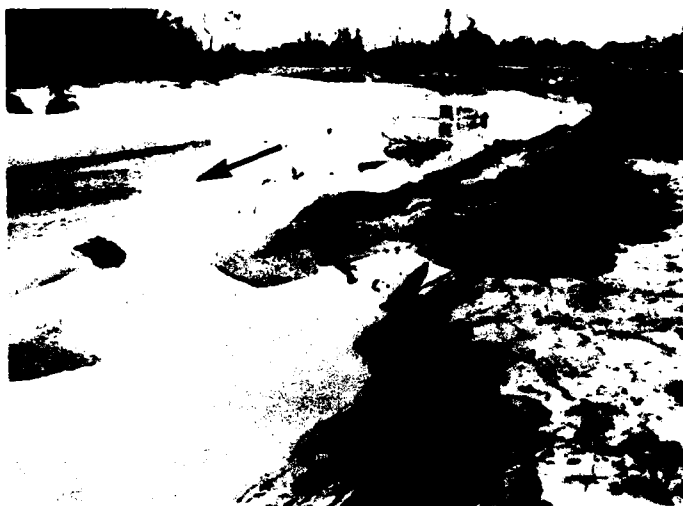
After Damage
Nov 1977

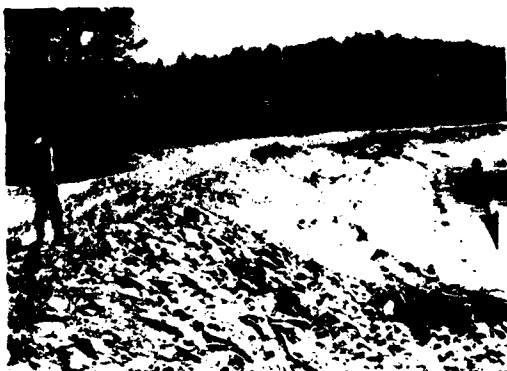
After Damage
Item 4A
Dec 1977

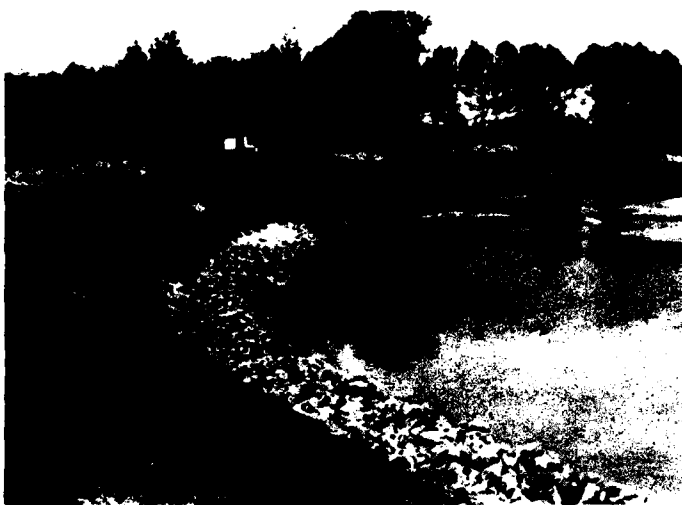
Damage Before 1981
Rehab

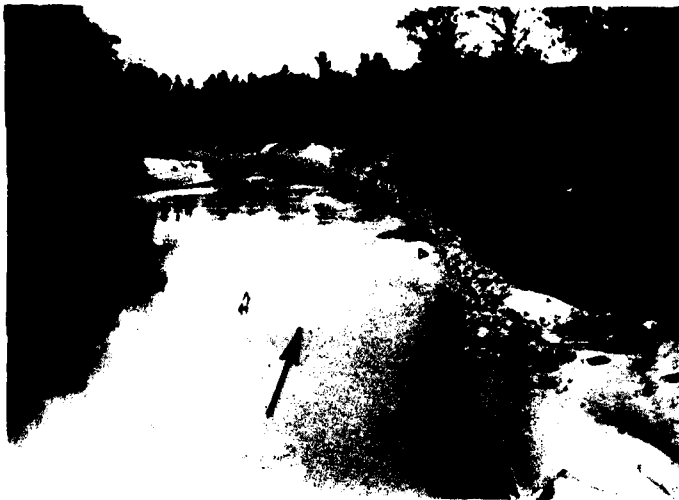
After Construction
Nov 1977

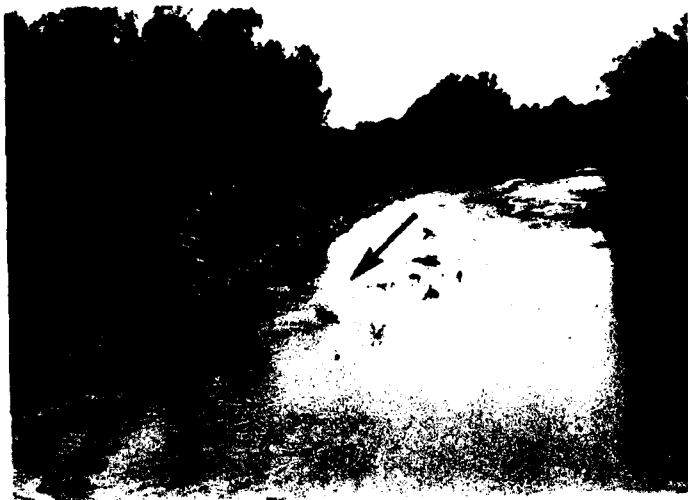
After Construction
Nov 1977
